CAPITAL FACILITIES PLAN

# GIG HARBOR FIRE & MEDIC ONE

SEPTEMBER 2021

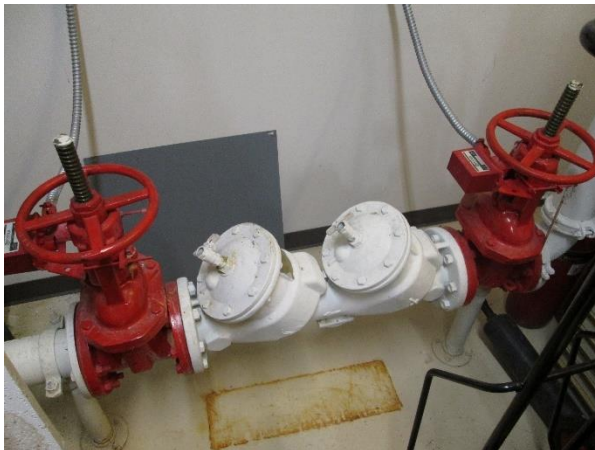
1. **Fire Protection:** The station has a full coverage wet sprinkler system.

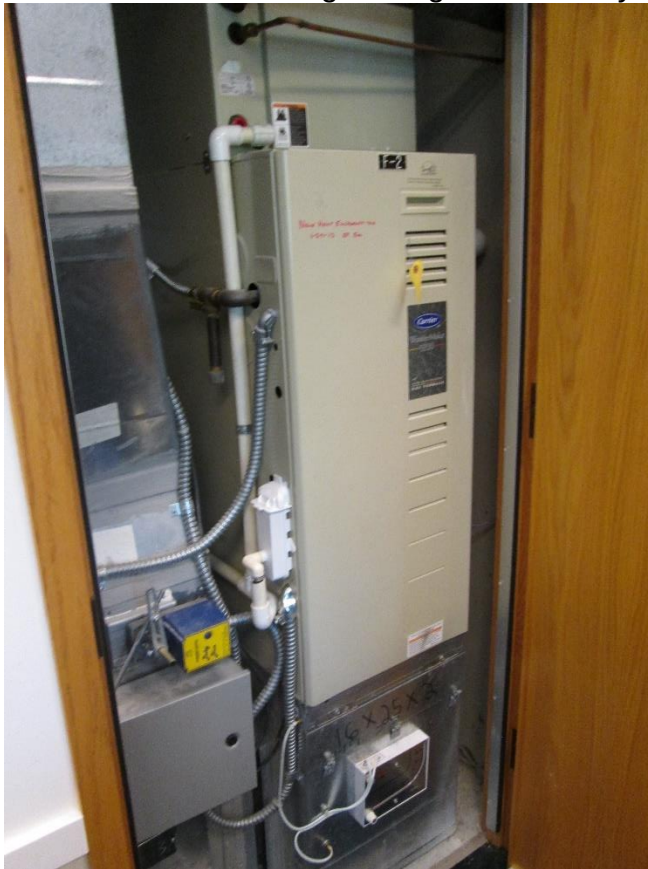
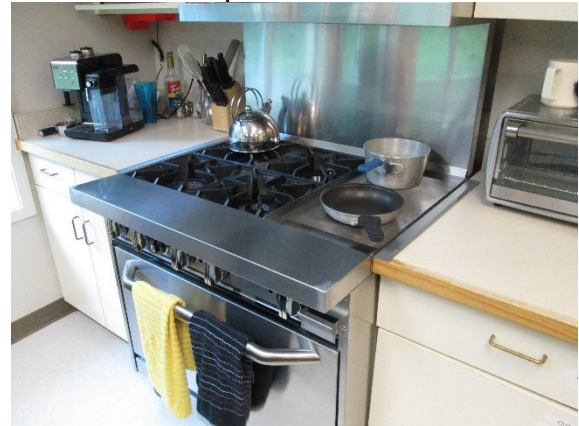
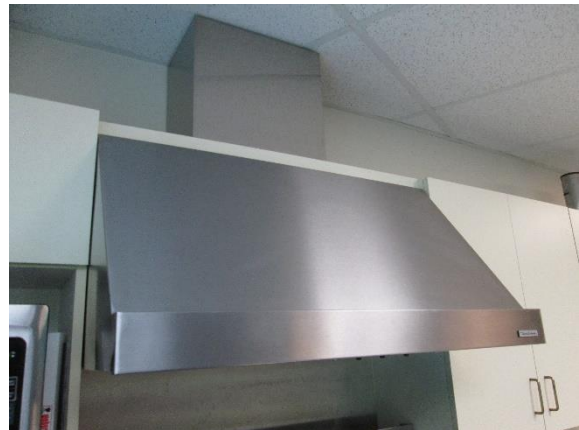
- c. **Zoning:** The station has several classrooms that each have their own ducted furnace. The other spaces throughout the station are served in groups by ducted furnaces on the corresponding level.
- d. **Refrigerant:** Most of the furnace/split systems utilize R-22 refrigerant while the newer system from 2009 uses R-410A refrigerant. The mini split system for the server uses R-410A refrigerant.
- e. **Range Hood:** A light duty commercial range hood is installed over a commercial gas range without any dedicated make-up air.

- 1. **Code Related:**
  - a. WAC 296-305-06503(15) requires new or remodeled kitchens to have cooking appliance disconnects active by alarm for gas and electricity. We recommend this be retrofitted for the existing kitchen.

- b. Code does require make-up air be provided for a kitchen hood exhaust system based on the volume of air exhausted. When replacing or upgrading kitchen hood or exhaust fan equipment we recommend installing a dedicated make-up air unit.
- c. Ventilation: The Energy Code requires that outside air ventilation for fire stations be provided independently of the heating and cooling system(s) and contain energy recovery. An ERV (Energy Recovery Ventilation) system is used to supply each space directly with outside air and recovery heat out of exhaust air from restrooms, laundry, etc. Any type of heating and cooling system(s) may be used with the ERV.

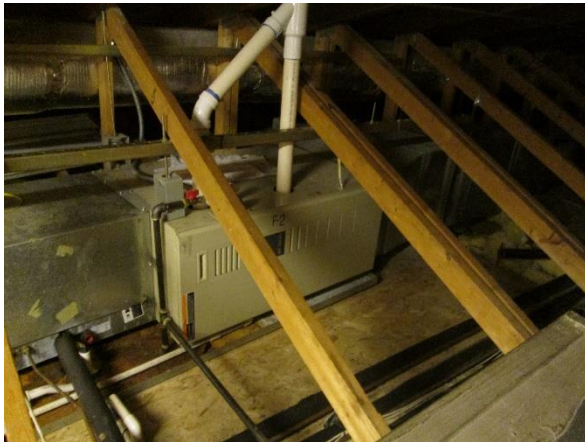
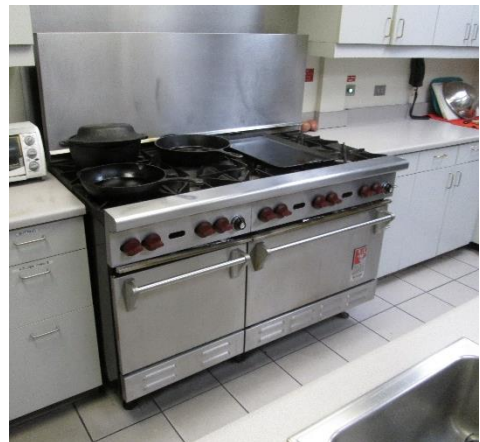
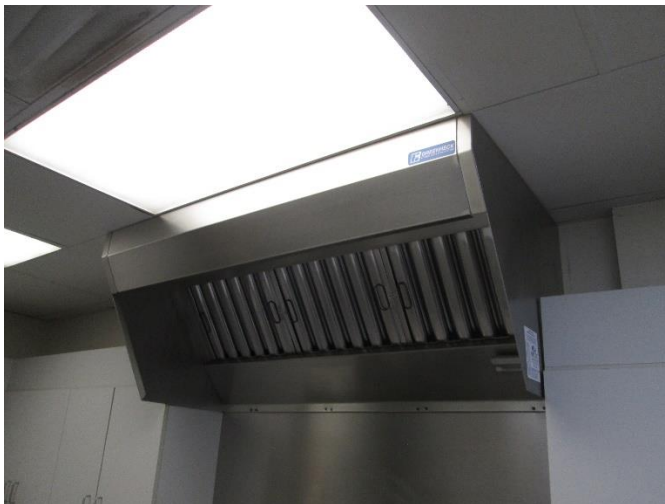
- split system furnace units are from 1999 and have exceeded their expected lifespan. The physical training room has a separate Mitsubishi mini split system with a wall cassette indoor unit from 2016.
- c. **Zoning:** The station is comprised of several zones that each with a programmable thermostat. The large zones tend to not provide adequate occupant comfort. As noted by one of the firefighters on staff, the thermostat positioning results in poor response from the ducted furnace systems. This system does not allow for individual sleep room controls.
  - d. **Refrigerant:** All of the ducted split system units utilize R-22 refrigerant. The mini split system serving the physical training room utilizes R-410A refrigerant.
  - e. **Range Hood:** A commercial range hood is installed over a commercial gas range but no make-up air was visible. The gas range has a dedicated reset button.

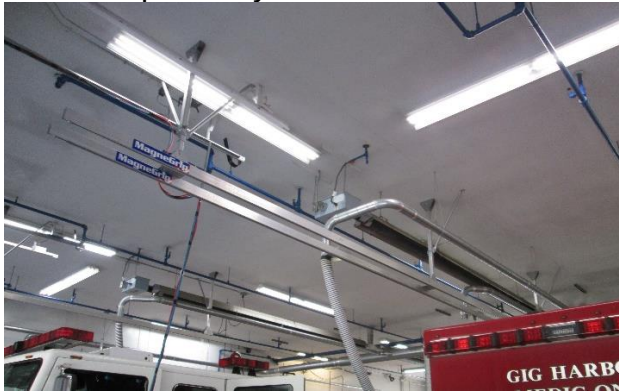
- a. **Ventilation:** There is general exhaust fan present that runs on a timer switch and appears to be in good condition. Currently, no make-up air is provided and CO or NO2 gas sensors are not present.
- b. **Source Capture Vehicle Exhaust:** The apparatus bay has a vehicle exhaust track system that is set up for 7 vehicles. The exhaust fan is mounted in the apparatus bay and appears to be in good condition.
- c. **Heat:** The large apparatus bay has four gas radiant tube heaters. The two smaller bays have individual gas unit heaters. There appears to be a few ducts and rails installed under the radiant heaters and within the clearance zone. The radiant heaters could cause damage to the ducts and rails due to the close proximity to the heaters.

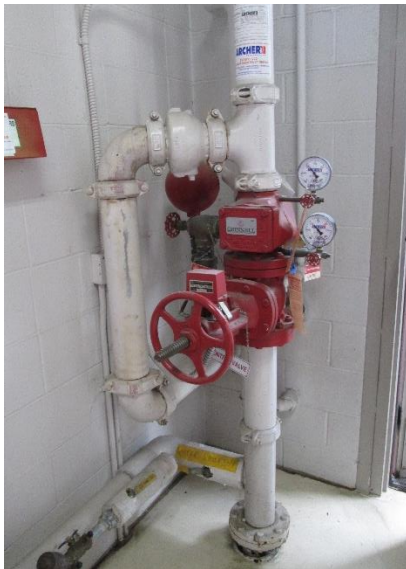
1. **Fire Protection:** The station has a full coverage wet sprinkler system.

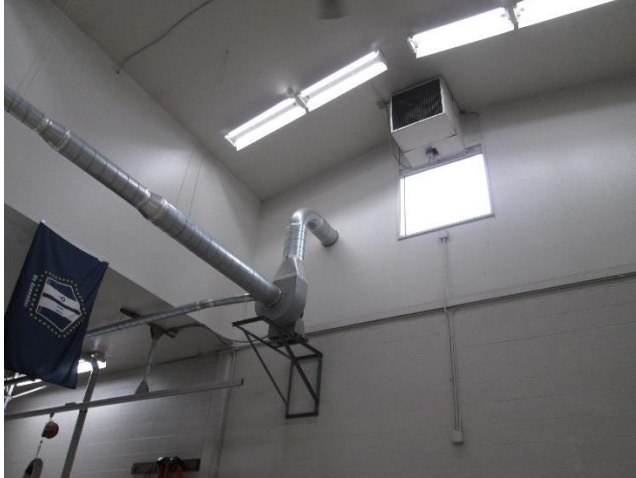
- c. **Heat:** The apparatus bay has two electric unit heaters. The apparatus bay layout would not accommodate infrared tube heaters due to the low ceiling height.

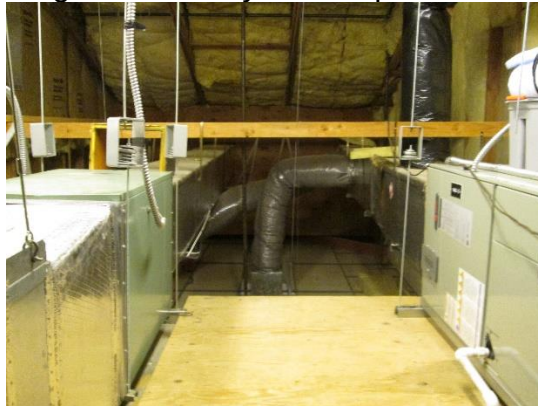
- c. **Zoning:** The station is comprised of three zones each with a programmable thermostat. The first zone includes the dorm and crew area. The kitchen, day room, office and lobby are a separate zone and the last zone serves the fitness room. The large zones for the dorm and kitchen areas do not provide adequate occupant comfort. This system does not allow for individual sleep room controls.
- d. **Refrigerant:** The Trane systems utilize either R-22 or R-410A refrigerant as defined above in the systems section. The Coleman system refrigerant was not identifiable due to fading on the name plate but R-22 refrigerant is likely used.
- e. **Range Hood:** A residential range hood is installed over a residential electric range without any make-up air.

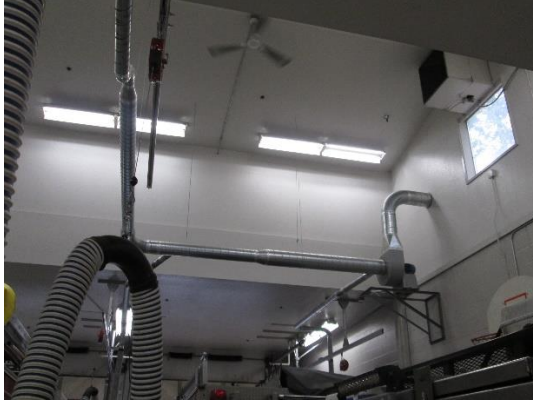
- c. **Heat:** The apparatus bay has two electric unit heaters. The apparatus bay layout would not accommodate infrared tube heaters due to the low ceiling height.

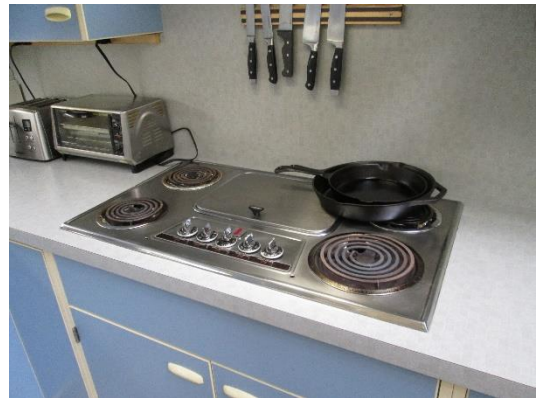
- e. **Range Hood:** A residential range hood is installed over a residential electric range without any make-up air.

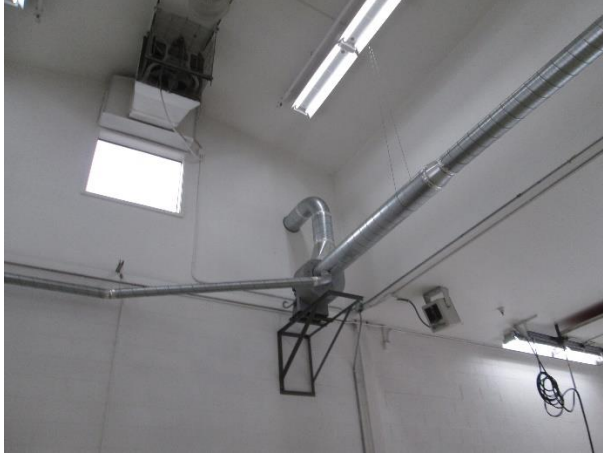
- c. **Heat:** The apparatus bay has two electric unit heaters. The apparatus bay layout would not accommodate infrared tube heaters due to the low ceiling height.

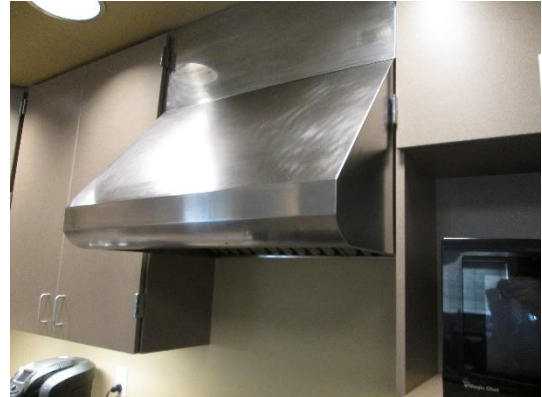
- e. **Range Hood:** A light commercial range hood is installed over a commercial propane range. A dedicated supply fan provides make-up air for the kitchen exhaust.

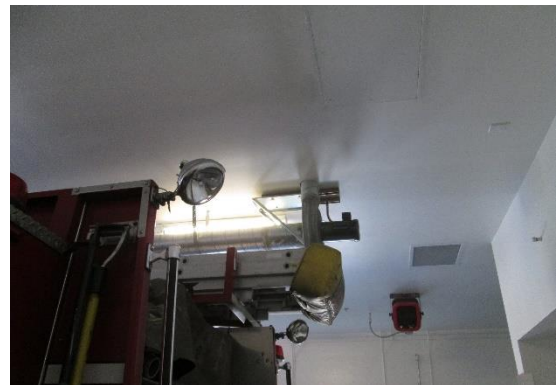
- a. **Ventilation:** There is general exhaust fan present that runs on an interval timer and appears to be in good condition. A motorized damper opens a louver for make-up air when the exhaust fan is running. CO or NO2 gas sensors are not present.
- b. **Source Capture Vehicle Exhaust:** The apparatus bay has a vehicle exhaust track system that is set up for 2 vehicles. The exhaust fan is mounted in the apparatus bay and appears to be in good condition.
- c. **Heat:** The apparatus bay has two electric unit heaters. The apparatus bay layout would not accommodate infrared tube heaters due to the low ceiling height.

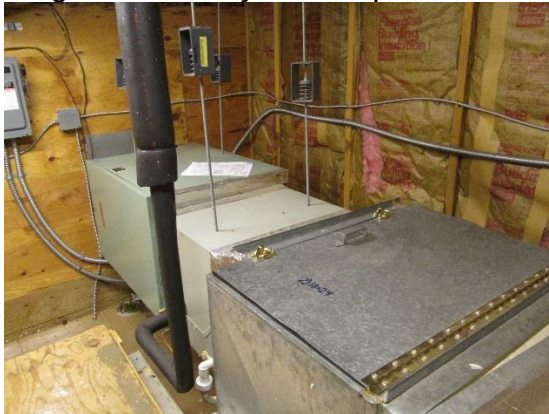
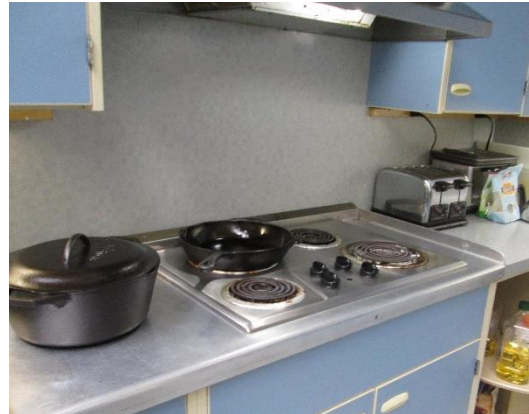
- d. **Refrigerant:** The Trane systems utilize either R-22 or R-410A refrigerant as defined above in the systems section.
- e. **Range Hood:** A residential range hood is installed over a residential electric range without any make-up air.

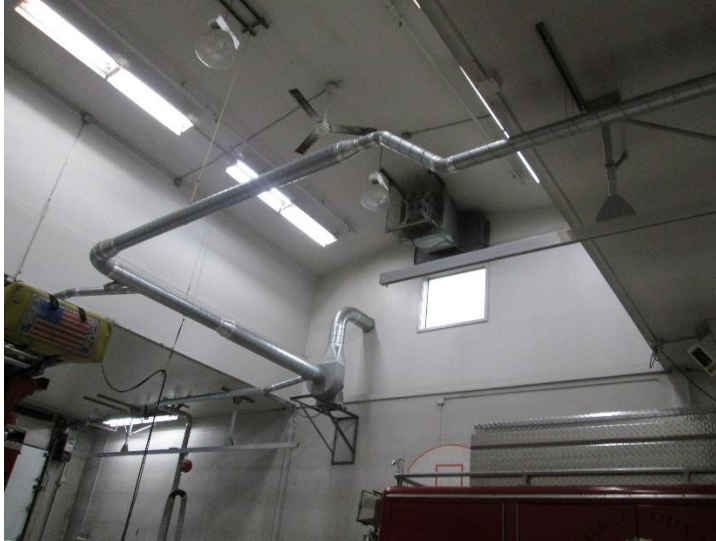
- c. **Heat:** The apparatus bay has two electric unit heaters. The apparatus bay layout would not accommodate infrared tube heaters due to the low ceiling height.
