## MEMORANDUM

Subject: GHFMO Headquarters Station 50 Tree Damage  
Site Visit Structural Observations

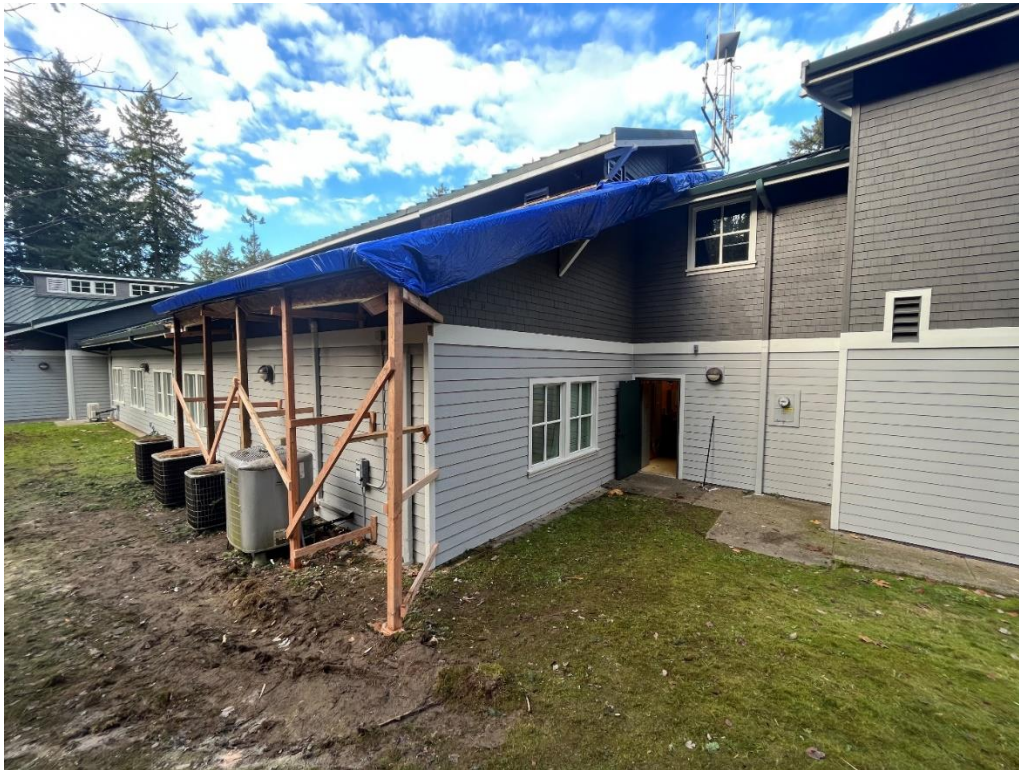
The tree fell on the southwest corner of the building where the building is a single story with a interstitial space with ductwork and sprinklers. The roof overhang had temporary wood supports and was covered by a tarp; see Image 1. The roof in this area is composed of lumber installed at a slope, that bears on the southern exterior wall and connects to the wall near the upper roof with metal connectors and a wood ledger. This forms the interstitial space with has a plywood floor that is supported by wood I-joists that span north-south and are supported by wood walls.

Image 1: Damaged Roof Area

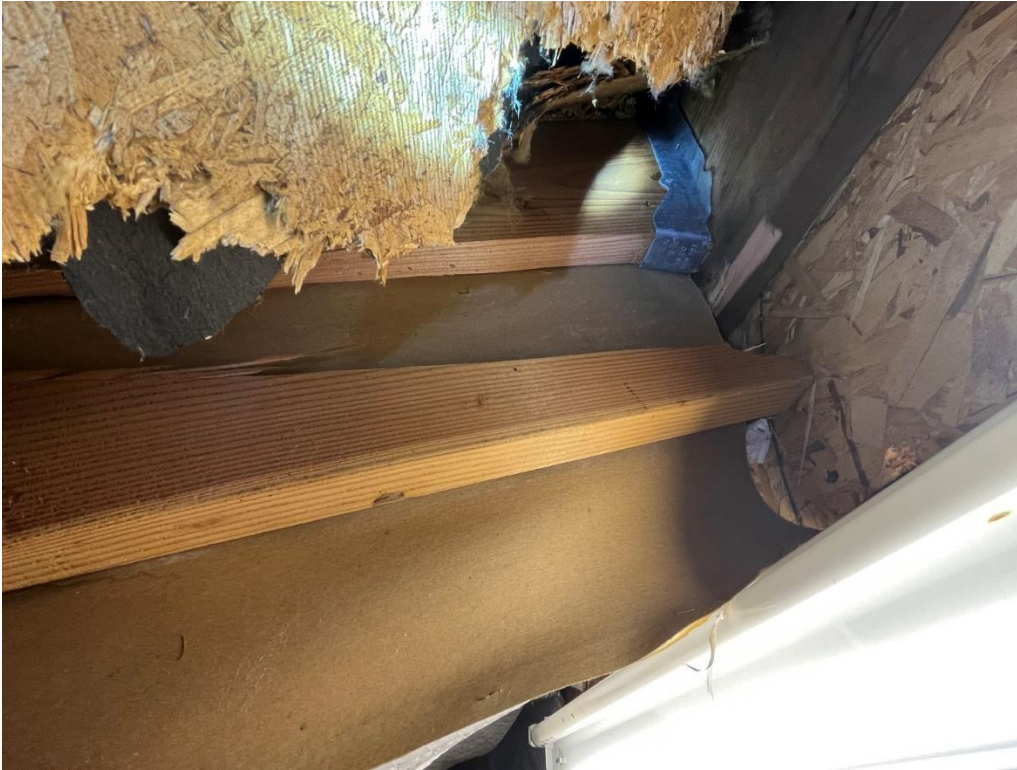
In the interstitial space, the eastern most portion could not be observed due to the existing damaged roof framing being present. To the western edge of the roof damaged space, multiple roof beams were observed to be split and no longer supported by the Simpson hangers at the ledger at northern wall; see Images 2 and 3. The wood ledger appeared flush with the wall where observable; the eastern end could not be observed. At the low end of the sloped roof, at the southernmost wall, the blocking, Simpson connector, and beam bearing points were observed; see Image 4. A gap was observed below the blocking and the wall top plate. Cracking was also observed horizontally across the blocking and at the Simpson connector.

Image 2: Interstitial Space Roof Joist at High Point

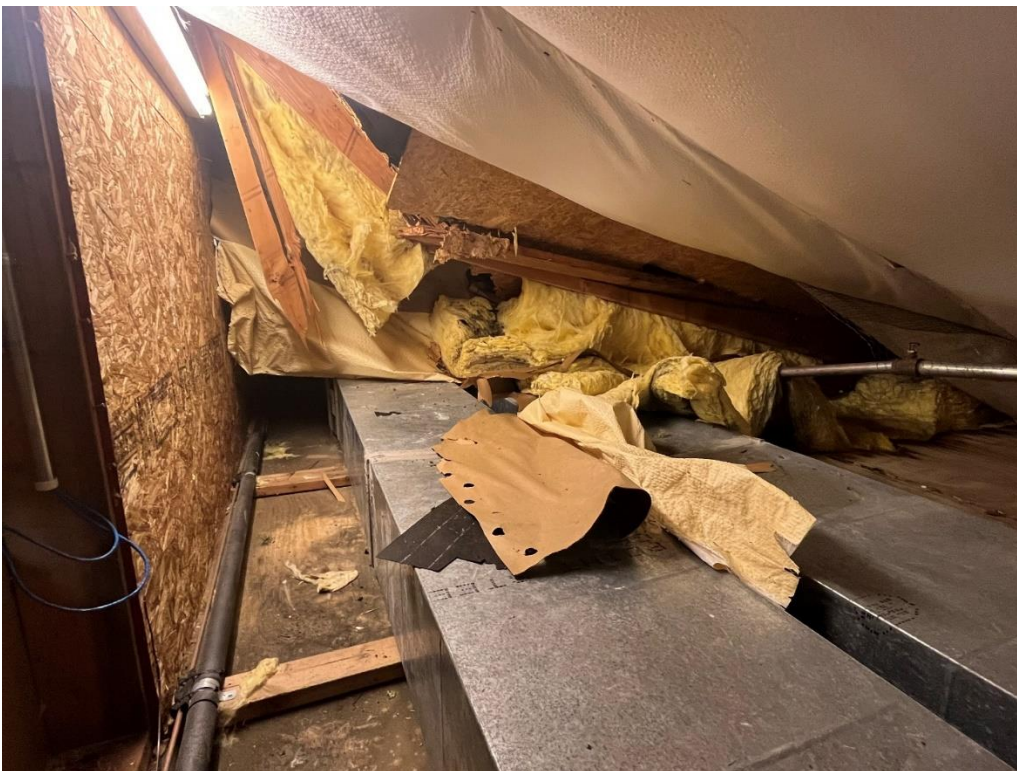
Image 3: Roof of Interstitial Space Looking East

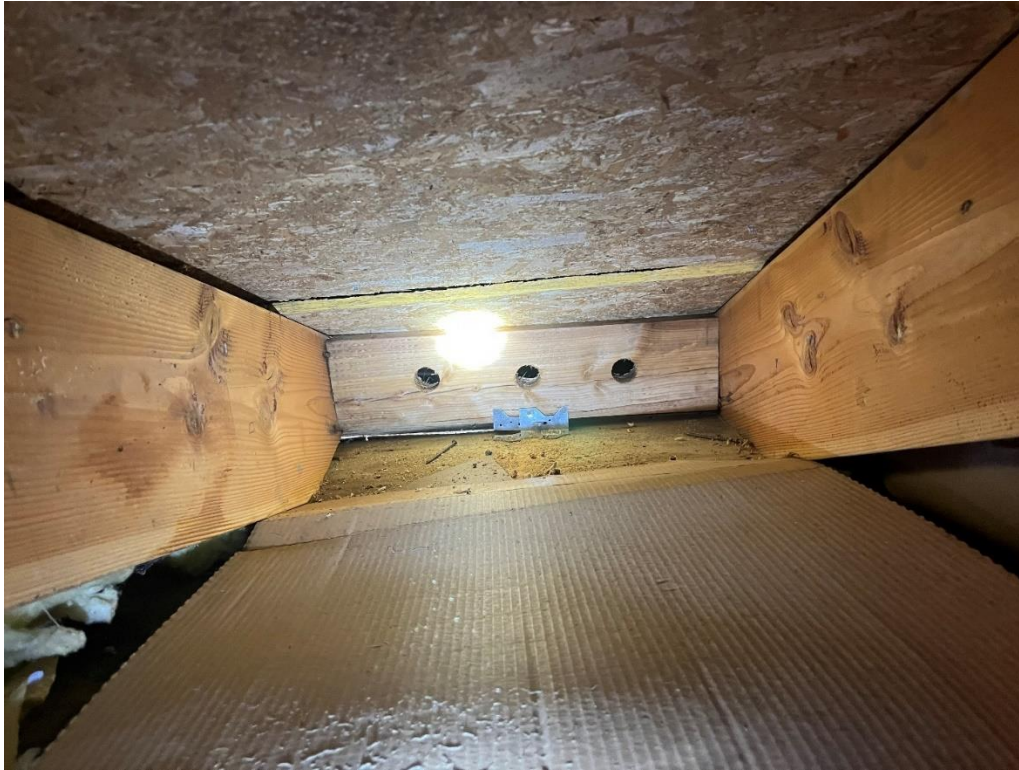
Image 4: Blocking at Southern Wall

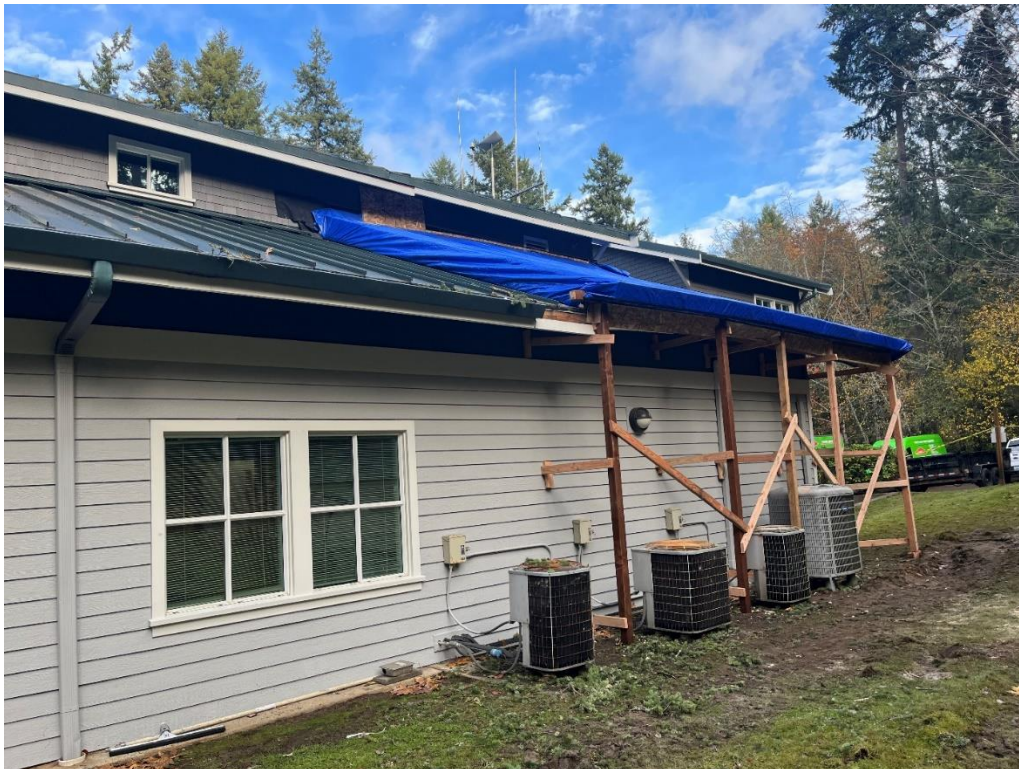
The high roof is composed of wood trusses and was also observed. The tree did not land on this portion of the roof, but the on-site staff noted that a portion of the tree had clipped the end façade and tails of a portion of the roof trusses. The approximate 3-foot-wide area could be observed from the exterior; see Image 5. At the interior, the bottom chord of the trusses appears to have a horizontal crack; see Image 6. The framing at the exterior wall could not be observed.

Image 5: Damaged Roof and Edge of High Roof

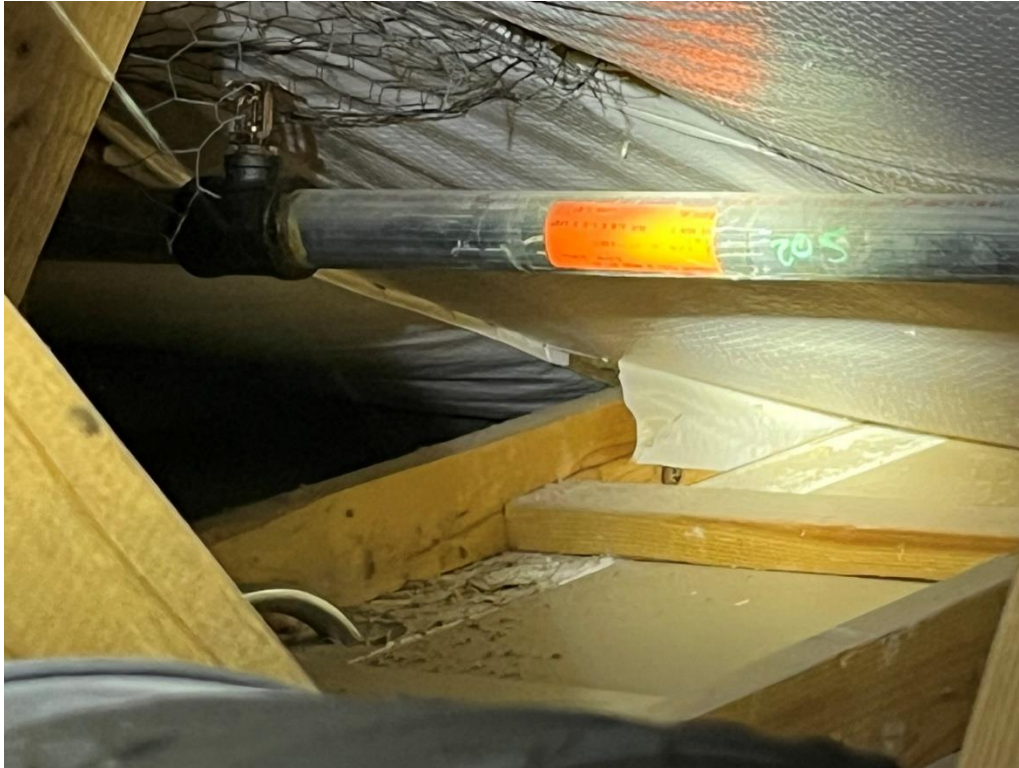
Image 6: High Roof Truss Bottom Chord Crack

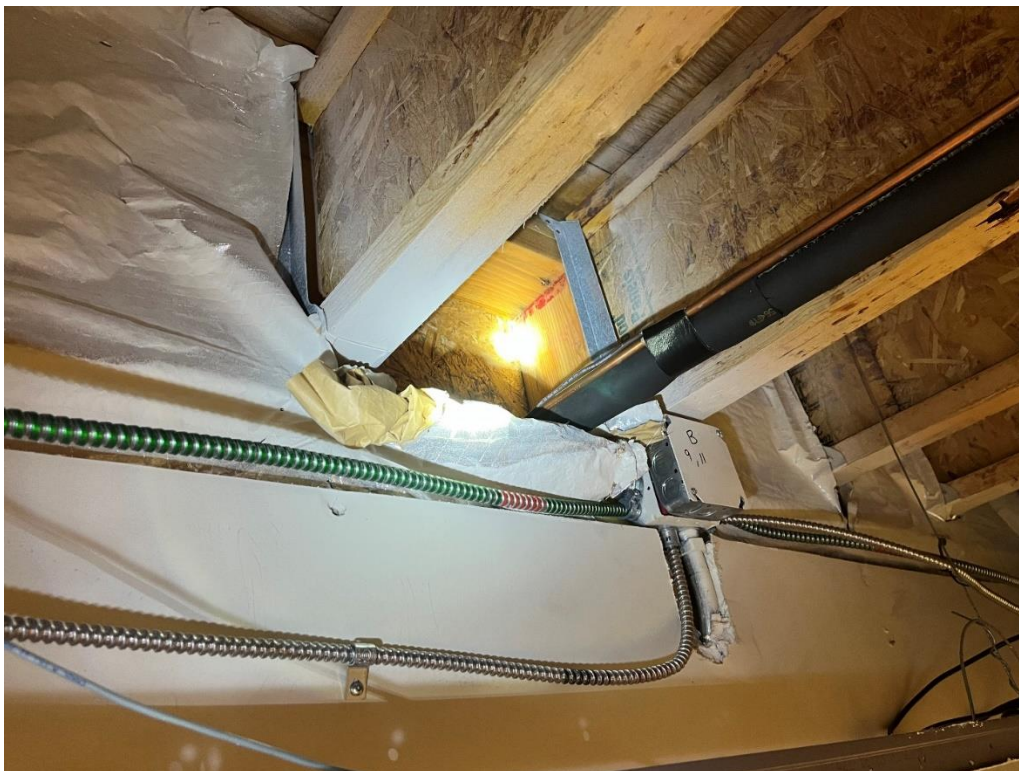
The I-joists of the floor of the interstitial space/roof of the office space were observed from below. No cracking was observed in the I-joist framing; see Image 7. Crushing of the sheathing above the joists was observed; See Image 8. Vertical cracking of the wall studs was also observed at the top of the wall; See Image 9. Minor Cracking of the top plate was also observed at the top of the wall studs; see Image 10.

Image 7: I-Joist Framing at Southern Wall

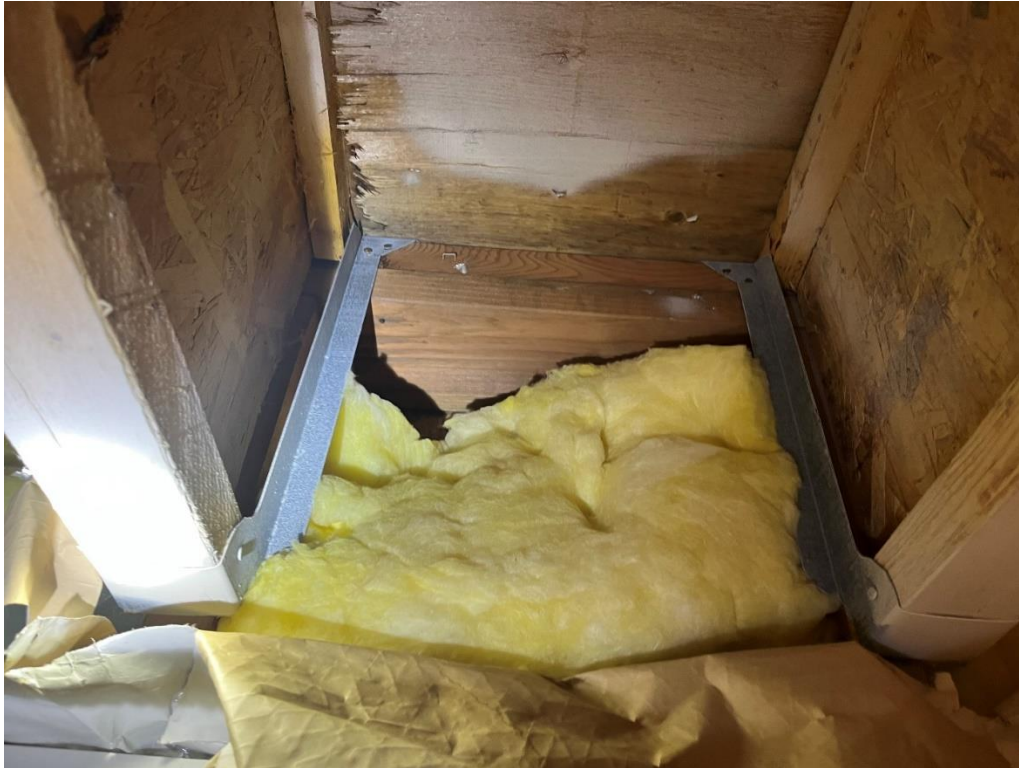
Image 8: Crushing of the Sheathing Above the I-joists

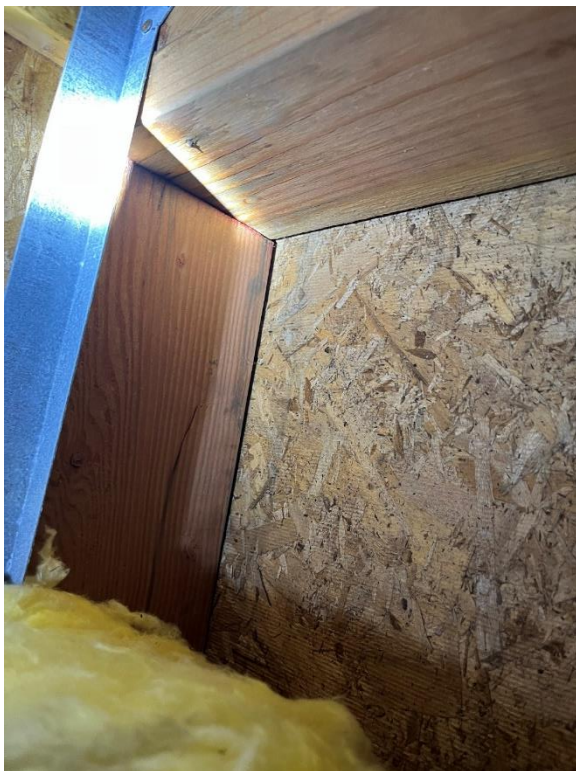
Image 9: Vertical Cracking of the Wall Stud

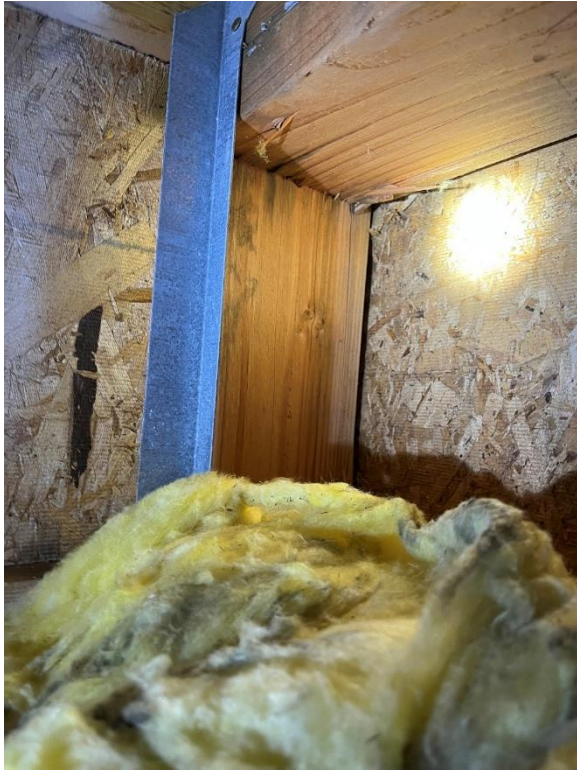
Image 10: Minor Cracking of Top Plate at Top of Wall Stud
