CAPITAL FACILITIES PLAN

# GIG HARBOR FIRE & MEDIC ONE

SEPTEMBER 2021

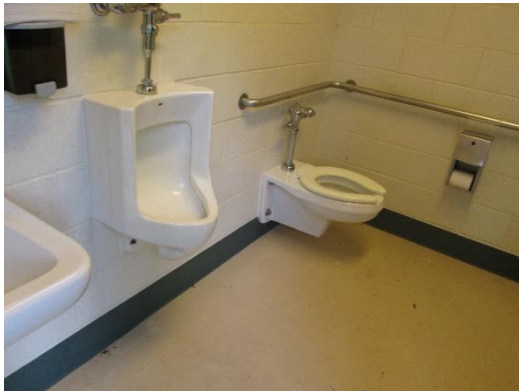
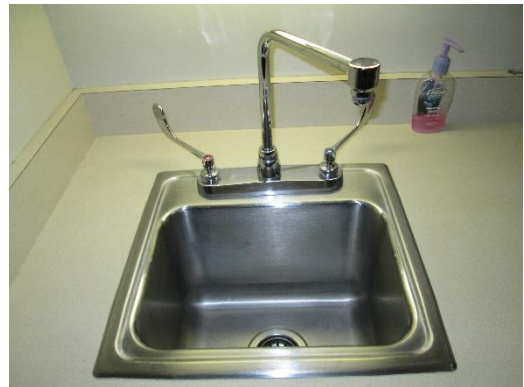
2. **Plumbing:**
  - a. Domestic hot water: The station is currently served by a single gas water heater with 120 MBH input and 75-gallon storage capacity. The water heater is from the late 1996 and has exceeded its expected lifespan. The system currently has a recirculation line and pump installed. The station is also equipped with a cold-water storage tank and domestic water booster pump for backup only.
  - b. Piping: Copper piping is used throughout and insulated.

- c. Water closets: China, flush valve, in good condition.
- d. Urinals: China, flush valve, in good condition.
- e. Lavatories: China, counter mounted with single handle faucets, in good condition. China, wall mounted with double lever faucet, in fair condition. Fixture supplies in good/fair condition.
- f. Sinks: Stainless steel, double bowl kitchen sink with single lever faucet, in fair condition. Stainless steel, single bowl sink with double lever faucet in fair condition (break room / hallway). Fiberglass utility sink with service sink faucet, in poor condition.
- g. Showers: Open shower configuration with shower heads or hand-held heads, in fair/poor condition.
- h. Drinking fountain: Stainless steel, refrigerated, hi-lo station in fair condition.

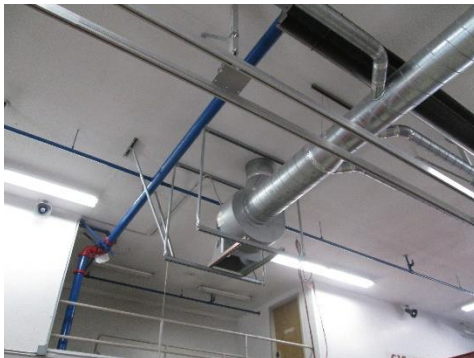
2. **Plumbing:**
  - a. Domestic hot water: The station is currently served by a gas water heater with 150 MBH input and 100-gallon storage capacity to serve the majority of the station. The station side has recirculation system and pump however there is no mixing valve downstream of the water heater. The water heater is from 1999 and has exceeded its expected lifespan. The support wing has a separate electric water heater to serve the decon sink, extractor and bathroom. The electric water heater was not accessible during the walkthrough so the age was not verified.
  - b. Piping: Copper piping is used throughout and insulated.

- c. Water closets: China, flush valve, in good condition. Water closet on support side is in poor condition.
- d. Urinals: China, flush valve, in good condition.

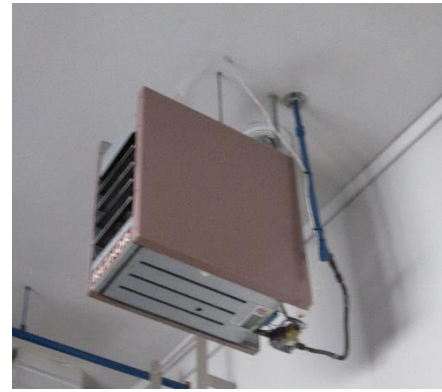
- a. **Ventilation:** There is general exhaust fan present that runs on a timer switch and appears to be in good condition. Currently, no make-up air is provided and CO or NO2 gas sensors are not present.
- b. **Source Capture Vehicle Exhaust:** The apparatus bay has a vehicle exhaust track system that is set up for 7 vehicles. The exhaust fan is mounted in the apparatus bay and appears to be in good condition.
- c. **Heat:** The large apparatus bay has four gas radiant tube heaters. The two smaller bays have individual gas unit heaters. There appears to be a few ducts and rails installed under the radiant heaters and within the clearance zone. The radiant heaters could cause damage to the ducts and rails due to the close proximity to the heaters.

1. **Operational Related:**
  - a. Plan on providing HVAC capability for individual temperature control in single sleep rooms.
  - b. Plan on providing new thermostats for the ducted furnace systems to reposition them to more effective locations for better system response.
  - c. Consider providing separate dedicated Decon space to contain and separate possible contamination from living and working areas. This space would also provide privacy when personal decontamination is required. Such a space would have high volume exhaust, infrared heat for comfort and drying, personal and equipment cleaning areas and full room drainage.
  - d. Consider providing make-up air louver(s) which would interlock and open when the app bay exhaust fan is operating.

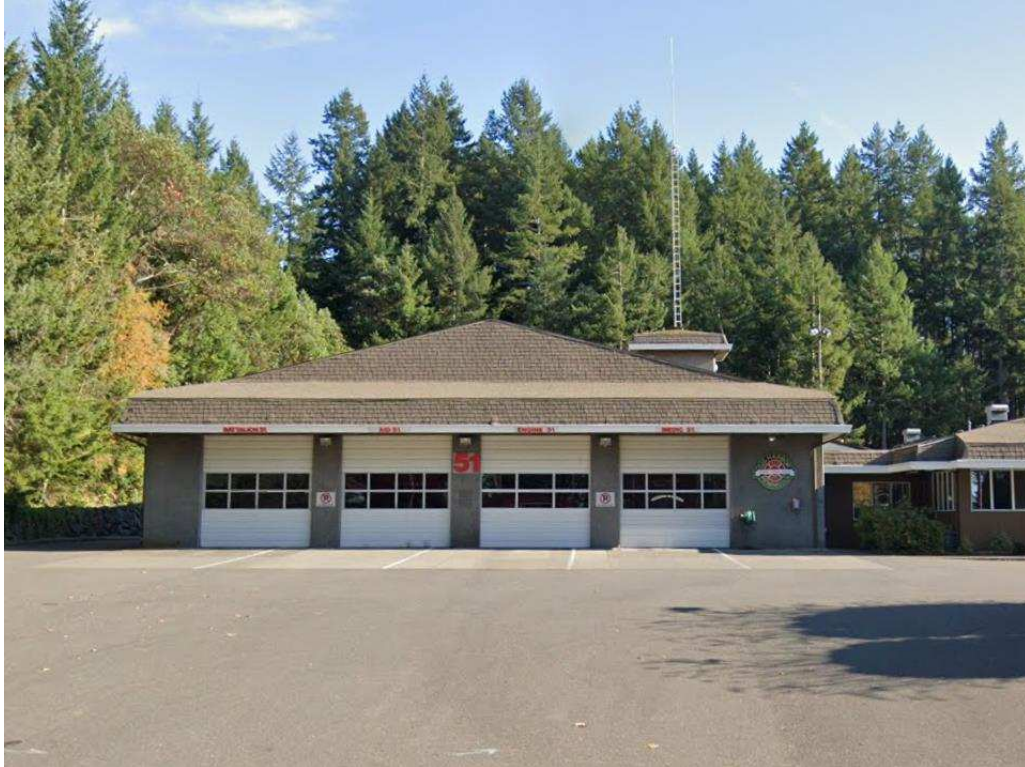
Figure 3.2-1. Fire Station 51, Apparatus Bay Exterior looking West.

Fire Station 51 is a one-story concrete tilt-up and wood-frame structure. The original construction of the building is unknown. The administration area of the building was remodeled to provide additional wood shear walls inside the building and PT room and exterior deck at the east façade. The building has distinct areas: an apparatus bay, and an administration area with dormitory, training room, office rooms, kitchen, dining, and miscellaneous living space. The original building has an approximate area of 12,500 square feet, and an addition added 550 square feet. The building is constructed of reinforced tilt-up concrete walls in the apparatus bay and wood walls in the administration area, supported by concrete foundation walls and continuous concrete footings. The roof diaphragm consists of plywood over timber trusses in both the apparatus bay and administration areas.

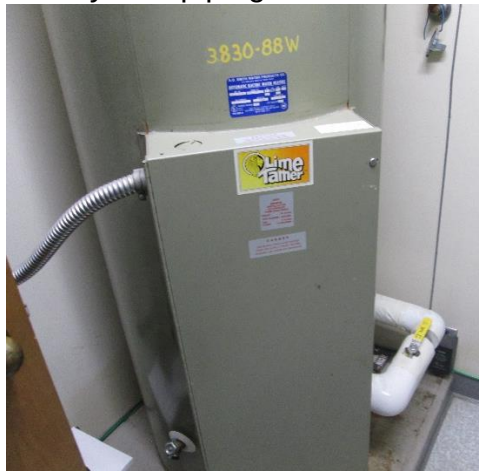
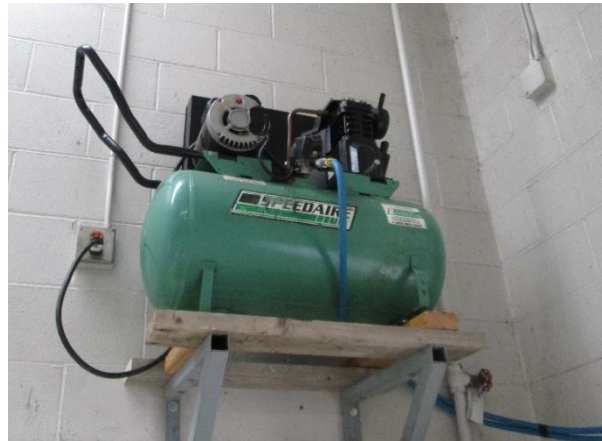
- b. Piping: Copper piping is used throughout and insulated.
- c. Water closets: China, tank type flush, in good condition. Fixture supplies are in fair/poor condition.

- d. Urinals: China, flush valve, in fair condition.
- e. Lavatories: China, counter mounted with single handle faucets, in good condition.
- f. Sinks: Stainless steel, double bowl kitchen sink with single handle faucet, in fair condition. Stainless steel, single bowl laundry sink with single handle faucet in fair condition. Stainless steel, single bowl fitness room sink with single handle faucet, in fair condition. Fiberglass utility sink with double handle sink faucet, in poor condition.

- g. Showers: Fiberglass enclosures with door, single knob mixing valve, in fair/poor condition.
- h. Drinking fountain: Stainless steel, refrigerated, single station in fair condition.

- i. Drains: The apparatus bay has small trench drains in each bay. The drains all connect to one waste line that drains to an oil/sand separator.
- j. Compressed Air: The station has an air compressor located in the app bay with piping to outlets for vehicle maintenance.

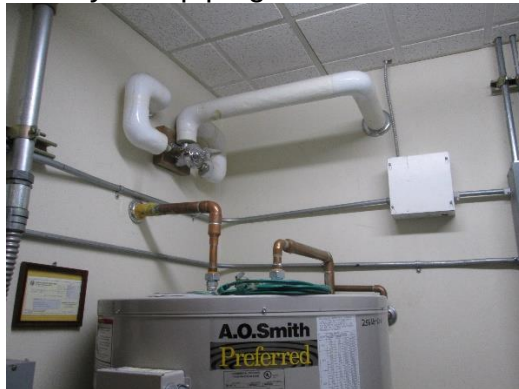
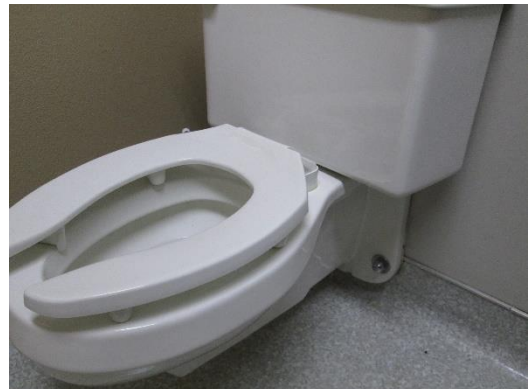
- e. Lavatories: China, counter mounted with single handle faucets, in good/fair condition.
- f. Sinks: Stainless steel, double bowl kitchen sink with single handle faucet, in fair condition. Stainless steel, single bowl laundry sink with single handle faucet in good condition. Stainless steel, single bowl fitness room sink with single handle faucet, in fair condition. Fiberglass utility sink with double handle service sink faucet, in poor condition.

- g. Showers: Fiberglass enclosures with door, single knob mixing valve, in poor condition.
- h. Drinking fountain: Stainless steel, refrigerated, single station in fair condition.

- i. Drains: The apparatus bay has small trench drains in each bay. The drains all connect to one waste line that drains to an oil/sand separator.
- j. Compressed Air: The station has an air compressor located in the app bay with piping to outlets for vehicle maintenance.

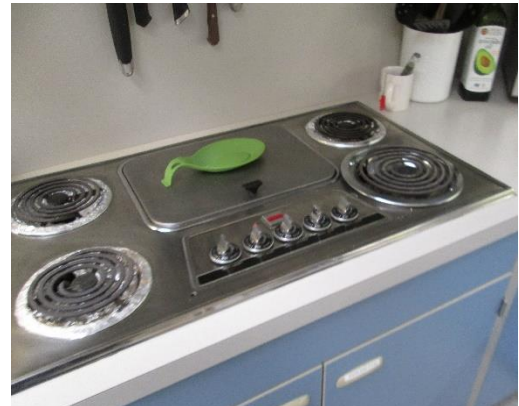
- c. **Zoning:** The station is comprised of three zones each with a programmable thermostat. The first zone includes the dorm and crew area. The kitchen, day room, office and lobby are a separate zone and the last zone serves the fitness room. The large zones for the dorm and kitchen areas do not provide adequate occupant comfort. This system does not allow for individual sleep room controls.
- d. **Refrigerant:** The Trane systems utilize either R-22 or R-410A refrigerant as defined above in the systems section. The Coleman system refrigerant was not identifiable due to fading on the name plate but R-22 refrigerant is likely used.
- e. **Range Hood:** A residential range hood is installed over a residential electric range without any make-up air.

- a. **Ventilation:** There is general exhaust fan present that runs on an interval timer and appears to be in good condition. Currently, no make-up air is provided and CO or NO2 gas sensors are not present.
- b. **Source Capture Vehicle Exhaust:** The apparatus bay has a vehicle exhaust track system that is set up for 3 vehicles. The exhaust fan is mounted in the apparatus bay and appears to be in good condition.

- c. Consider providing make-up air louver(s) which would interlock and open when the app bay exhaust fan is operating.
2. **Code Related:**
  - a. WAC 296-305-06503(15) requires new or remodeled kitchens to have cooking appliance disconnects active by alarm for gas and electricity. We recommend this be retrofitted for existing kitchens.

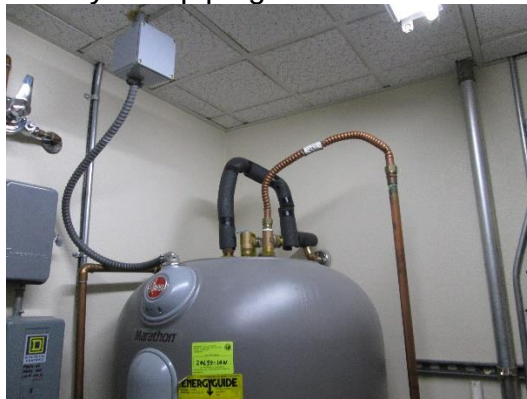
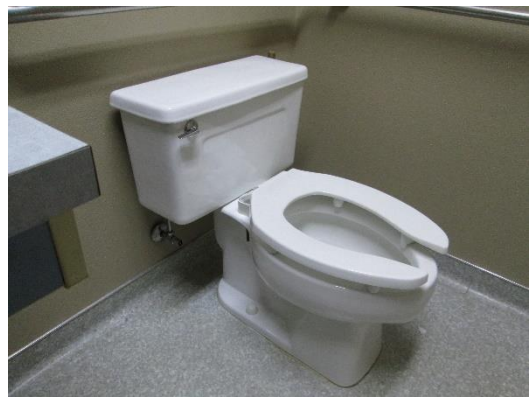
- d. Urinals: China, flush valve, in fair condition.
- e. Lavatories: China, counter mounted with single handle faucets, in good/fair condition.
- f. Sinks: Stainless steel, double bowl kitchen sink with single handle faucet, in fair condition. Stainless steel, single bowl laundry sink with single handle faucet in good condition. Stainless steel, single bowl fitness room sink with single handle faucet, in fair condition. Fiberglass utility sink with double handle sink faucet, in poor condition.

- g. Showers: Fiberglass enclosures with door, single knob mixing valve, in poor condition.
- h. Drinking fountain: Stainless steel, refrigerated, single station in fair condition.

- i. Drains: The apparatus bay has small trench drains in each bay. The drains all connect to one waste line that drains to an oil/sand separator.
- j. Compressed Air: The station has an air compressor located in the app bay with piping to outlets for vehicle maintenance.

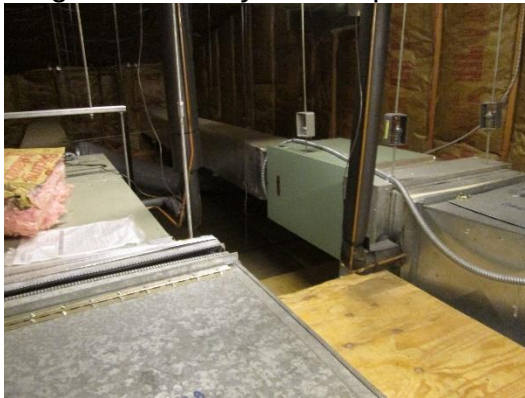
- b. **Systems:** The station has three ducted split system furnaces with ground mounted condensing units. Two of the three systems are full Trane systems (furnace, coil and condensing unit) that are 1 (R-410A refrigerant based) and 13 years old (R-22 refrigerant based). The third system is a Coleman system from the late 1980s. The Coleman system has reached its expected lifespan and the other older Trane system is nearing their end.

- d. **Refrigerant:** The Trane systems utilize either R-22 or R-410A refrigerant as defined above in the systems section. The Coleman system refrigerant was not identifiable due to fading on the name plate but R-22 refrigerant is likely used.

- e. **Range Hood:** A residential range hood is installed over a residential electric range without any make-up air.

3. **Maintenance Related:**
- a. Most split systems use R-22 refrigerant and cannot be directly replaced due to the phase out of that refrigerant. When considering replacement or upgrade of split system equipment, it will need to utilize newer refrigerant such as R-410A. This will necessitate replacing not only the exterior condensing unit but also the indoor coil and the refrigerant piping as well.

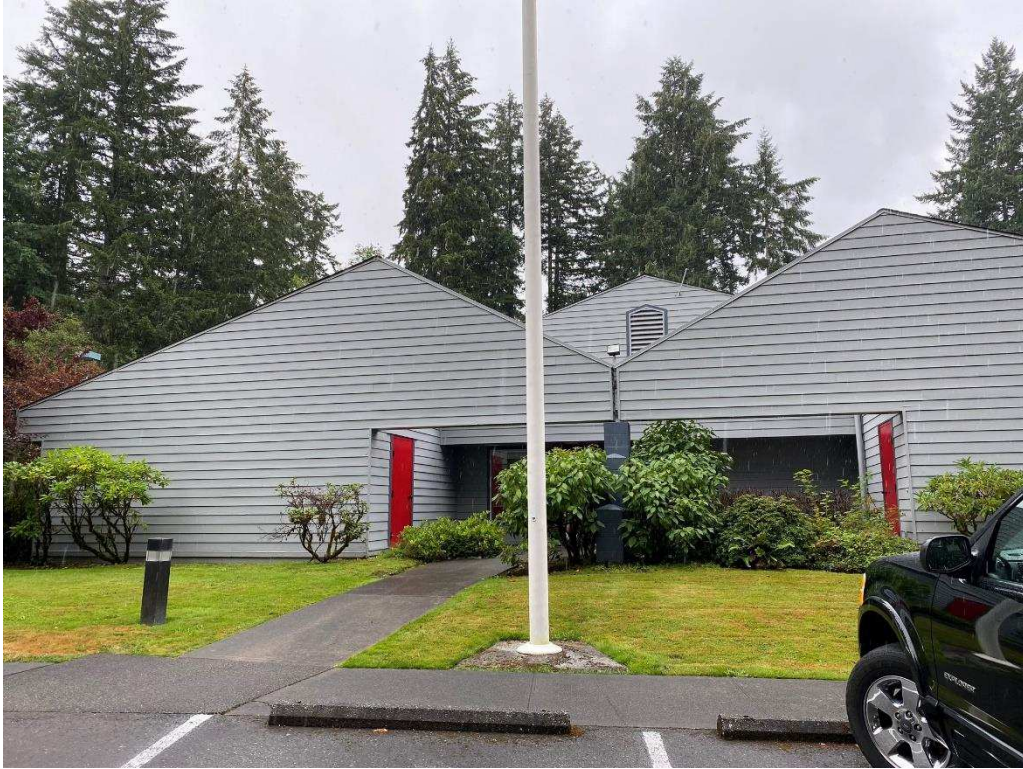
**Figure 3.1-1. Fire Station 58 Exterior, Public Entrance.**

Fire Stations 52, 54, 55, 56, 58, and 59 are one-story masonry and wood-frame structures constructed in 1987. The stations were constructed from the same drawings set and site visits indicate that they were built similarly. The buildings have distinct areas: an apparatus bay and a residence area with sleeping rooms, kitchen, and miscellaneous living space. The apparatus bays and adjacent residence spaces combine for a total building area of approximately 6,070 square feet. The buildings are constructed of reinforced masonry walls in the apparatus bays and wood walls in the residence areas, supported by continuous concrete footings. The roof diaphragms consist of plywood over timber trusses in both the apparatus bays and the residence areas.

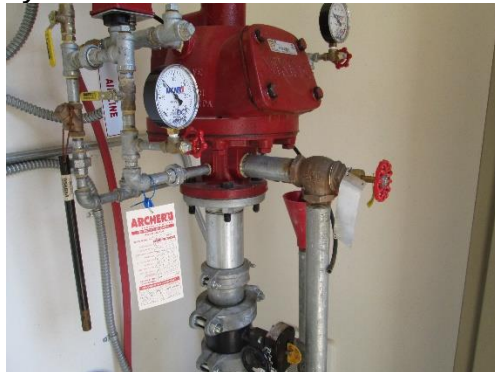
1. **Fire Protection:** The station has a full coverage wet and dry sprinkler system.

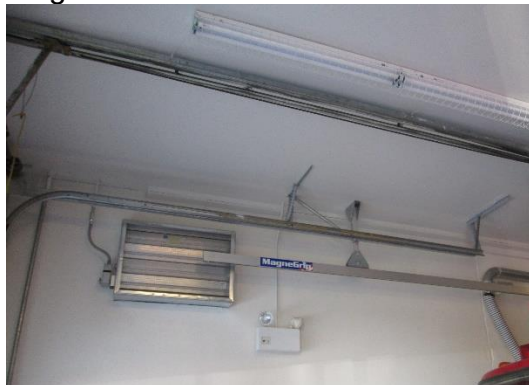
- a. **Ventilation:** There is general exhaust fan present that runs on an interval timer and appears to be in good condition. A motorized damper opens a louver for make-up air when the exhaust fan is running. CO or NO2 gas sensors are not present.
- b. **Source Capture Vehicle Exhaust:** The apparatus bay has a vehicle exhaust track system that is set up for 2 vehicles. The exhaust fan is mounted in the apparatus bay and appears to be in good condition.
- c. **Heat:** The apparatus bay has two electric unit heaters. The apparatus bay layout would not accommodate infrared tube heaters due to the low ceiling height.

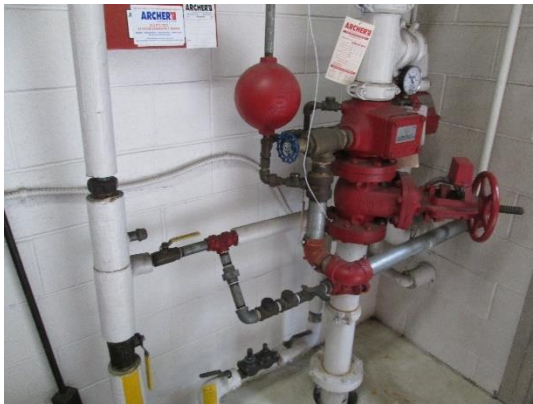
1. **Fire Protection:** The station has a full coverage wet sprinkler system.

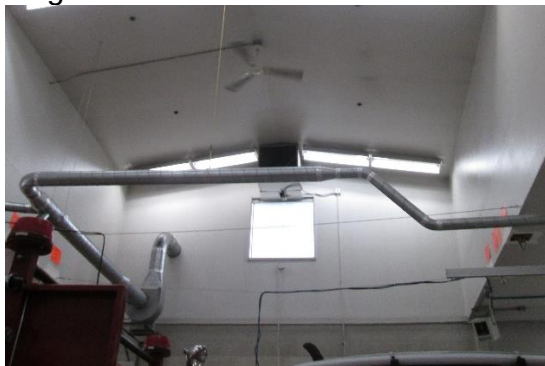
- a. **Ventilation:** There is general exhaust fan present that runs on an interval timer and appears to be in good condition. Currently, no make-up air is provided and CO or NO2 gas sensors are not present.
- b. **Source Capture Vehicle Exhaust:** The apparatus bay has a vehicle exhaust track system that is set up for 3 vehicles. The exhaust fan is mounted in the apparatus bay and appears to be in good condition.
- c. **Heat:** The apparatus bay has two electric unit heaters. The apparatus bay layout would not accommodate infrared tube heaters due to the low ceiling height.

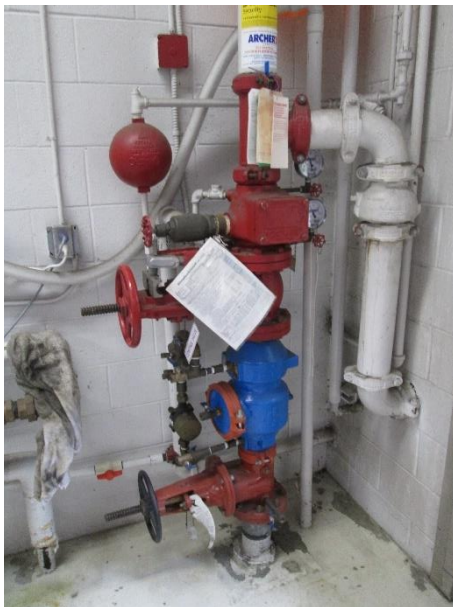
1. **Fire Protection:** The station has a full coverage wet sprinkler system.

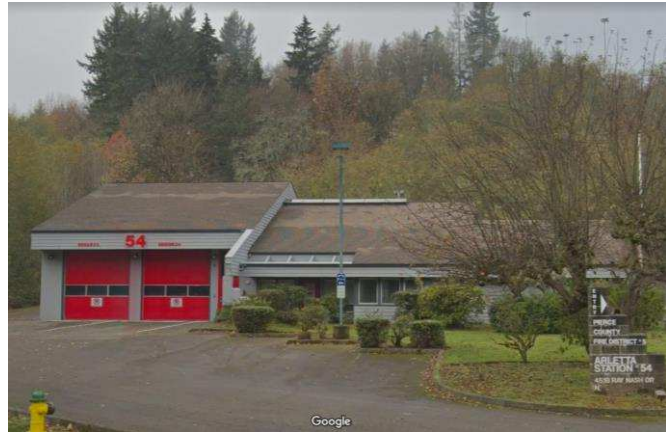
Year Built: 1987  
Number of Stories: 1  
Floor Area: 6,720 SF  
Address: Various locations in Gig Harbor, WA

Fire Stations 52, 54, 55, 56, 58, and 59 are one-story masonry and wood-frame structures constructed in 1987. The stations were constructed from the same drawings set and site visits indicate that they were built similarly. The buildings have distinct areas: an apparatus bay and a residence area with sleeping rooms, kitchen, and miscellaneous living space. The apparatus bays and adjacent residence spaces combine for a total building area of approximately 6,070 square feet. The buildings are constructed of reinforced masonry walls in the apparatus bays and wood walls in the residence areas, supported by continuous concrete footings. The roof diaphragms consist of plywood over timber trusses in both the apparatus bays and the residence areas.

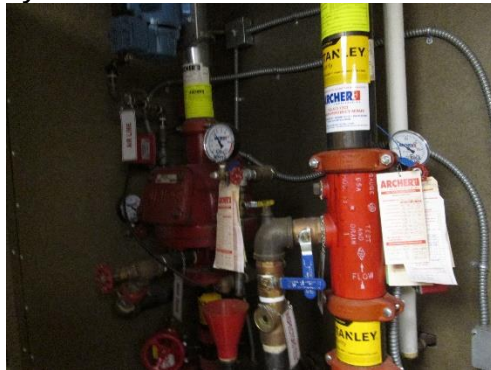
1. **Fire Protection:** The facility has a full coverage wet sprinkler system and dry system for outdoor covered areas.

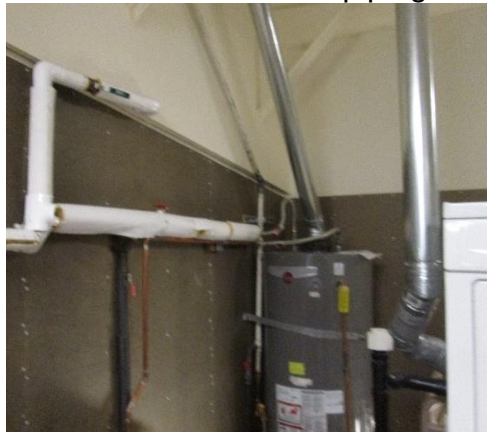
2. **Plumbing:**
  - a. Domestic hot water: The facility is currently served by a single gas water heater with 75 MBH input and 98-gallon storage capacity. The water heater appears to be from 2015 and should still have 10 years of life.
  - b. Piping: Copper piping is used throughout and is mostly insulated.
  - c. Water closets: China, flush valve, in good condition.
  - d. Urinals: China, flush valve, in good condition.
  - e. Lavatories: China, wall mounted with single handle faucet, in good condition.

- f. Sinks: Stainless steel, double bowl sink with single handle faucet, in good condition. Stainless steel utility sinks with double handle sink faucet, in fair/poor condition.
- g. Showers: Fiberglass enclosure, single knob mixing valve, handheld shower head in fair condition. Emergency shower head pull station and emergency eye wash in good condition.
- h. Drinking fountain: Stainless steel, refrigerated, hi-lo station in good condition.
- i. Drains: The maintenance bay has trench drains positioned in front of each bay door. The trench drains and other floor drains from parking areas all connect to one waste line that drains to an oil/sand separator.
- j. Compressed Air: The facility has an air compressor located in the mech/fire room with piping to various outlets throughout.

- a. Split systems that use R-22 refrigerant cannot be directly replaced due to the phase out of that refrigerant. When considering replacement or upgrade of split system equipment, it will need to utilize newer refrigerant such as R-410a. This will necessitate replacing not only the exterior condensing unit but also the indoor coil and the refrigerant piping as well.
- b. We recommend replacing the domestic water heater in-kind within 10 years.

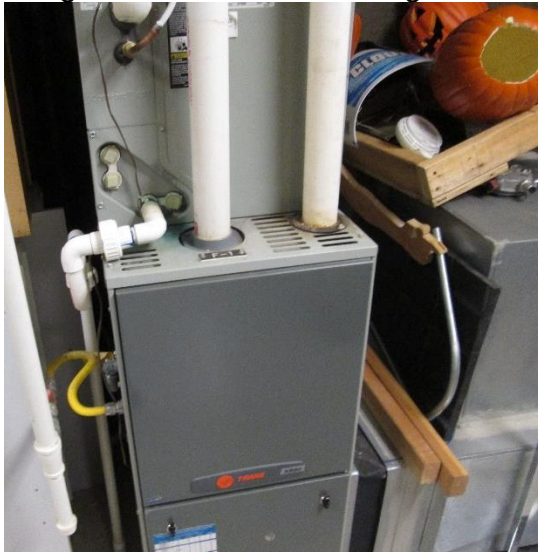
- 3. **Natural Gas:** The facility does have a natural gas service and is piped to gas furnaces, unit heaters, water heater, dryer and equipment washers. Steel piping is used throughout and in fair condition.
- 4. **HVAC – Facility North and South Wings**
  - a. **Ventilation:** There are two exhaust fans that serve the restrooms. The mech/fire room has an individual exhaust fan. Fresh air for each north and south wing is brought in by two ducted furnaces.
  - b. **Systems:** The facility has one ducted gas furnace on the north wing and a ducted split system gas furnace with ground mounted condensing unit for the south wing. Both sets of equipment were installed in 2002 and are near the end of their expected lifetime.

- c. **Zoning:** The facility is comprised of two zones each with a programmable thermostat. The north zone includes most of the first and second floor spaces of the north wing. The south zone includes the break room, entry and work spaces on the south wing. The south wing furnace also provides supply air into the restrooms.
- d. **Refrigerant:** The single furnace split system is rated for both R22 or R410A refrigerant, so the exact refrigerant used was not confirmed.

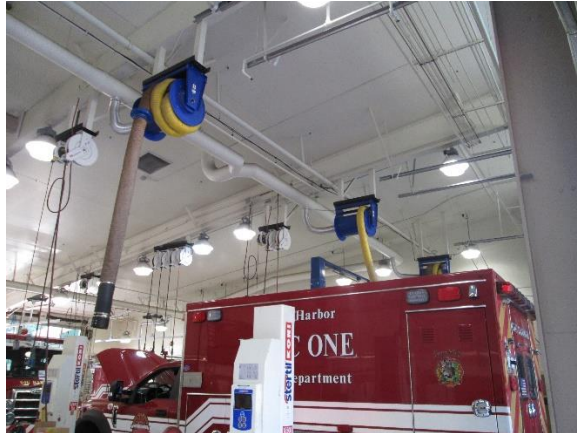
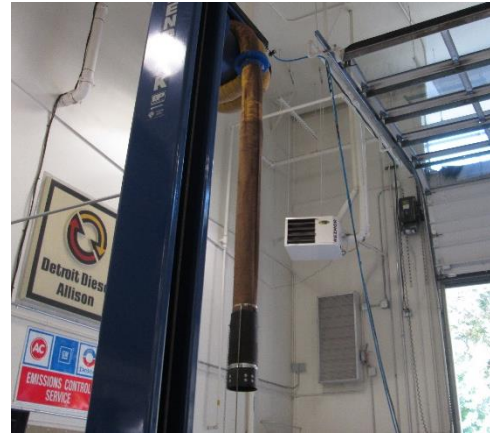
- a. **Ventilation:** In the large maintenance bay there is a general exhaust fan present that runs on a switch, condition was not verified since the fan is located on the roof. Make-up air is provided via louvers above the entry doors includes a CO gas sensor. The smaller single bay has a general exhaust fan with a louver for make-up air and CO gas sensor.
- b. **Source Capture Vehicle Exhaust:** The large maintenance bay has a vehicle exhaust reel system with several exhaust hoses positioned close to the bay doors. The exhaust fan is mounted on the roof and the condition was not verified. No source capture exhaust present in the smaller single maintenance bay.

- c. **Heat:** The large maintenance bay has two gas unit heaters. The large maintenance bay layout has a tall ceiling and could accommodate infrared tube heaters. The small single bay has one gas unit heater and a lower ceiling.

1. **Operational Related:**
  - a. Consider adding two gas unit heaters at the northwest and southeast corners of the large maintenance bay to improve heat distribution. Note that this requires gas line modification due to the additional gas load from the heaters.
